FACILITY CONDITION ASSESSMENT

AIRPORT TERMINAL

FEBRUARY 2016

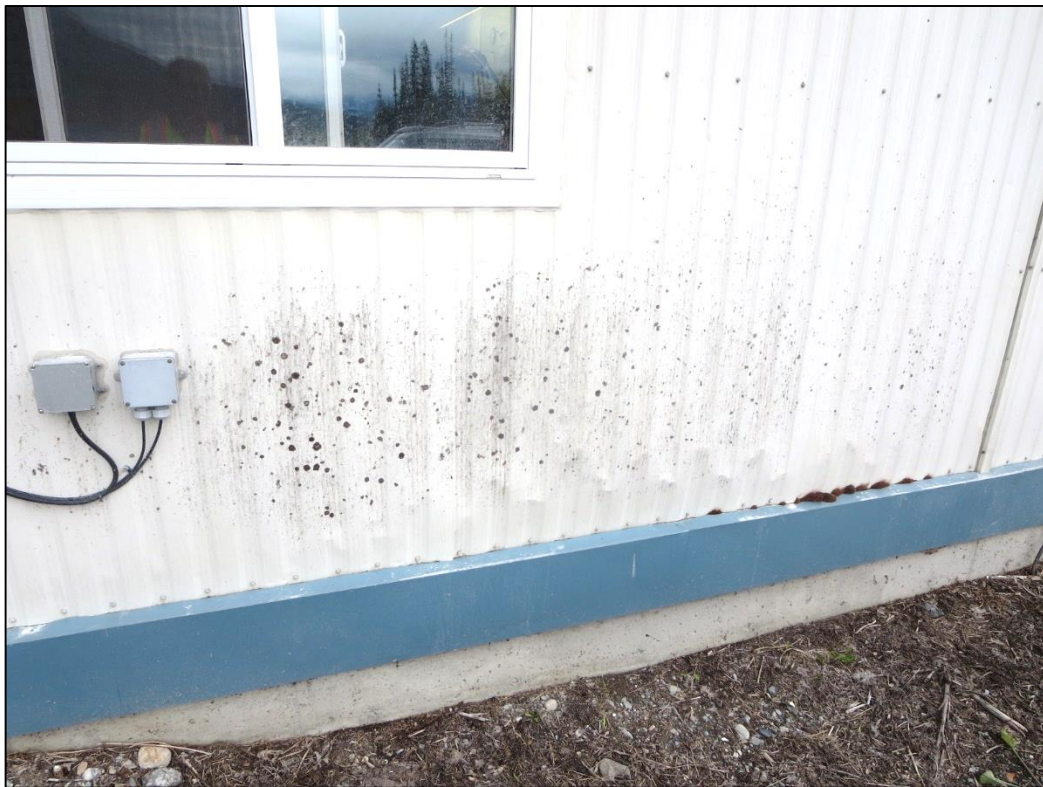
Photo B9 - north wall showing expanded metal cladding

The metal cladding is buckling outward. This is quite unusual and may be indicative of water getting into the wall cavity and expanding when frozen.

At the present time, there is no evidence of water on the interior wall surface.

This is the north side of the building so it gets minimum sunshine. The wall cladding should be pressure washed to remove the growth on the walls.

The only significant issue is the buckling on the north wall as noted in Section 3. This should be investigated to determine the cause and whether it affects the integrity of the wall.

In any case, the cladding should be removed and the situation assessed.

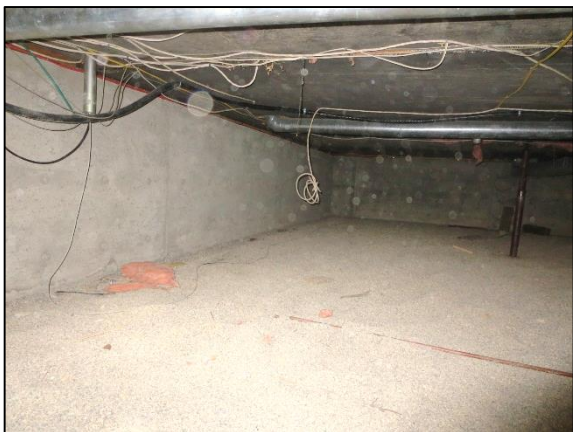
The foundation for the Airport Terminal building is poured concrete walls providing a low crawlspace beneath. The foundation is in good condition with no significant concerns visible. The crawlspace walls are insulated and it was very dry inside. It would be wise to ensure the foundation insulation continues to be covered from the elements and possible damage.

Photo B19 - crawlspace walls and floor

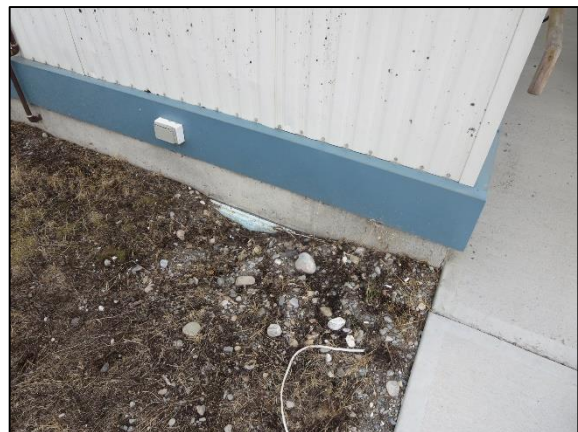
Photo B11 - showing foundation insulation

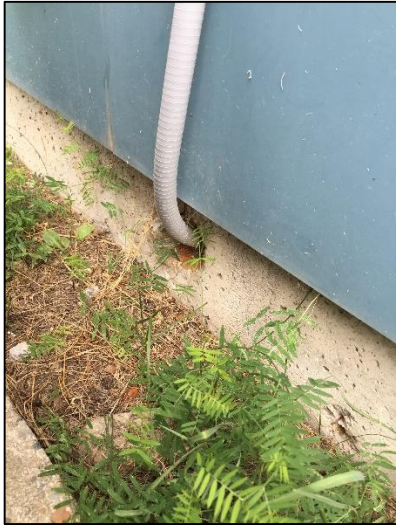
The only other issue identified was exterior penetrations into the crawlspace. These should be sealed.

Photo E10 - sample penetration

- a. Exterior foundation and wall penetrations should be properly sealed

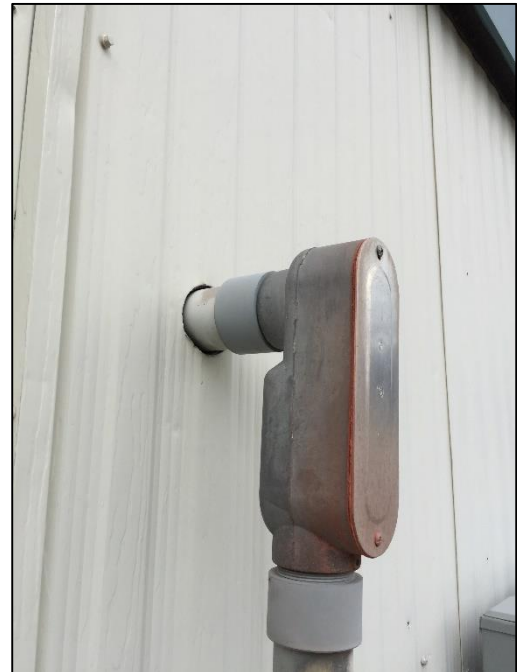
There are several wall penetrations that should also be sealed to keep moisture out of the wall cavity.

Photo E19 - example of exterior wall penetration

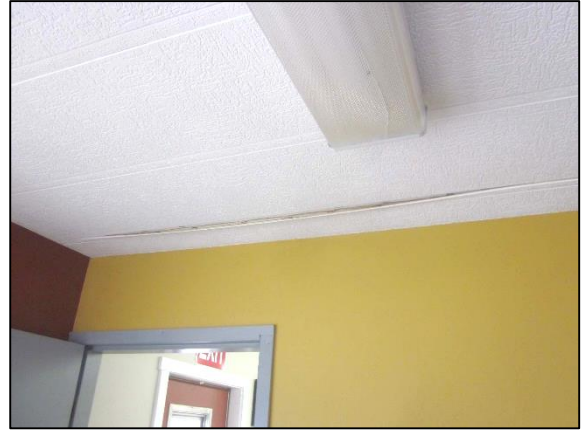
Interior walls are generally gypsum wallboard and are in reasonable condition. Ceilings are pre-manufactured panels and are showing some wear and tear. The floors are linoleum and are in good condition.

Photo A27 - separated ceiling panel

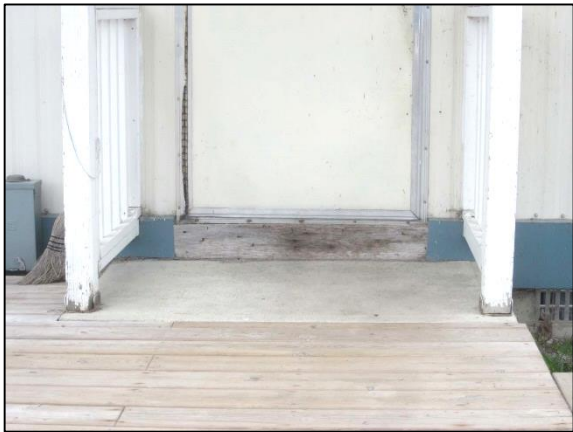
Photo A9 - airside door stoop

The exterior stoop at the west airside door is exposed wood. Even though this is covered by a porch roof, it should be sealed or covered similar to the exit door at the east end of the building.

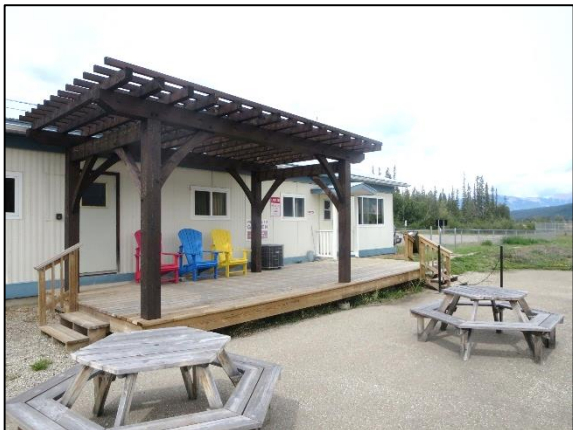
The pergola and deck is in very good condition, however, the deck of the gazebo is showing normal wear and tear and would benefit from a waterproof re-surfacing.

Photo B4 - gazebo

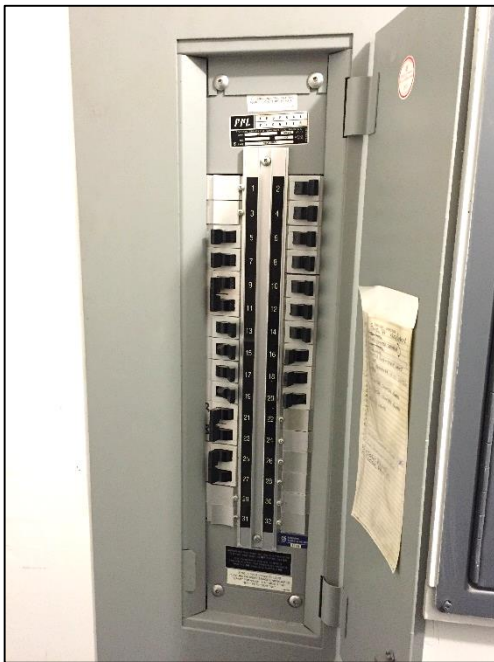
Photo E3 - electrical panel

The circuit breaker panel should be re-labelled for clarity and the exposed coiled wire at the side of the building should be made safe.

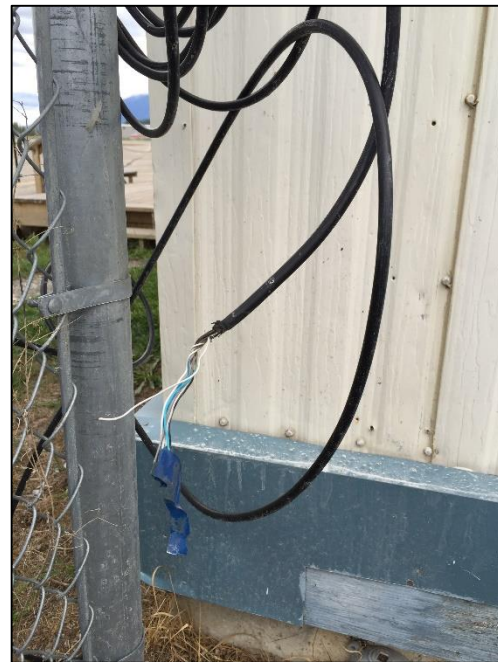
Photo E7 - exposed wire

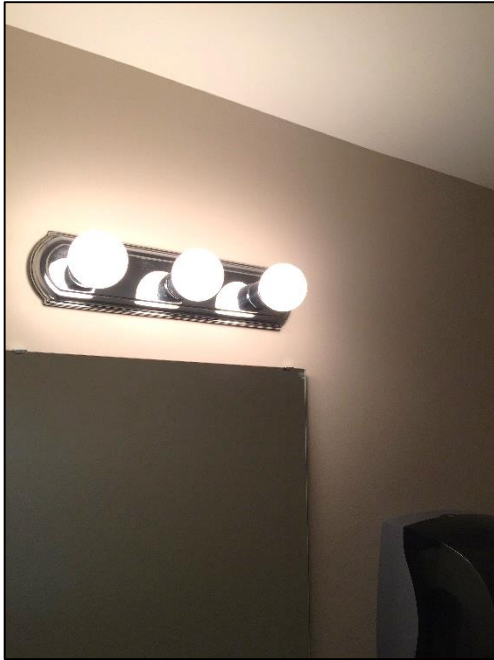
Photo E5 - incandescent lamps

The existing incandescent lamps could be replaced with compact fluorescents or LED lamps for energy savings.

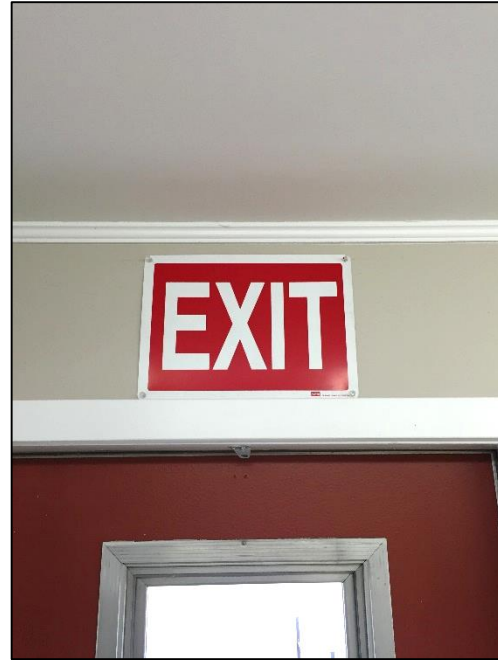
The exits are marked but are not illuminated. Although all doors lead directly to the exterior, the signage could be considered for upgrading.

Photo E11 - existing exit signage

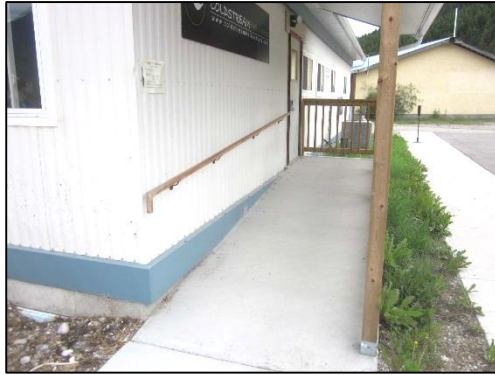
- b. The building is not handicap accessible. A wheelchair ramp was installed to the front door but there is no handicap actuators to open/close the door. The door threshold is raised and would be difficult for a wheelchair occupant to negotiate the threshold while trying to keep the door open.

Photo A24 - front entrance ramp

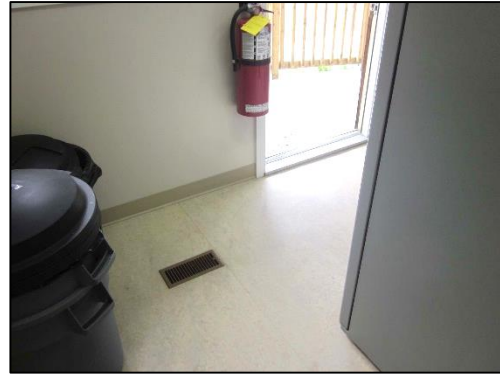
Photo A22 - front door threshold
