Town of Golden

**Facility Condition Assessment Report
Golden Municipal Swimming Pool**

October 27, 2020

Prepared by:
FCAPX a Division of Roth IAMS Ltd.
Project No. 20079
www.fcapx.com

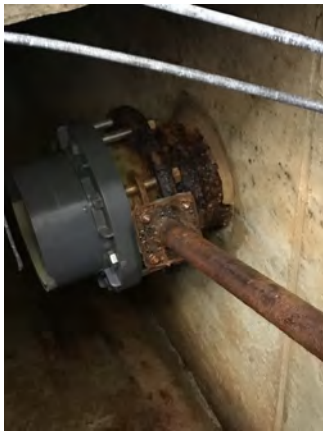
Golden Municipal Swimming Pool - A202001

At the time of assessment the basement walls were reportedly leaking around pipe penetrations in the filter pit. A repair cost has been provided. The Remaining Useful Life has been maintained with the assumptions that repairs will take place.

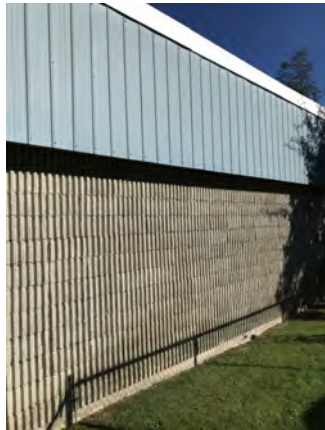
Golden Municipal Swimming Pool - B103001

No major deficiencies were observed or reported during the assessment. It was reported onsite that block walls are not well insulated, resulting in heat loss in colder weather. A study has been created to provide insulating options for the facility.

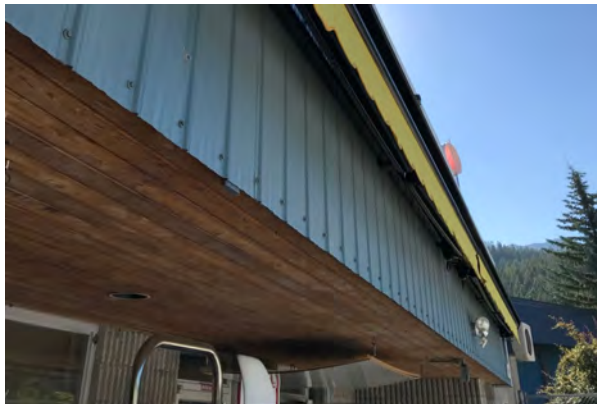
Golden Municipal Swimming Pool - B201026

No major deficiencies were observed or reported during the assessment; however due to the age of the wood it is recommended to routinely monitor exposed sections for signs of deterioration as a preventative maintenance activity. It is likely that this component will require replacement prior to any block wall/structural replacements or large scale repairs.

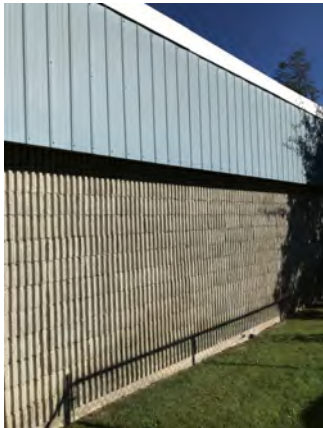
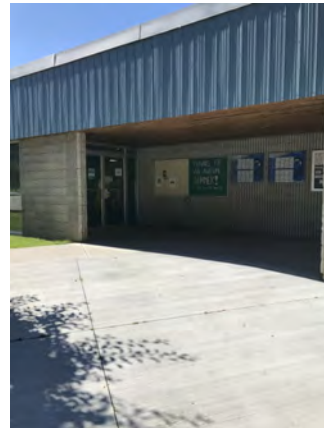
Golden Municipal Swimming Pool - B201024

No major deficiencies were observed or reported during the assessment.

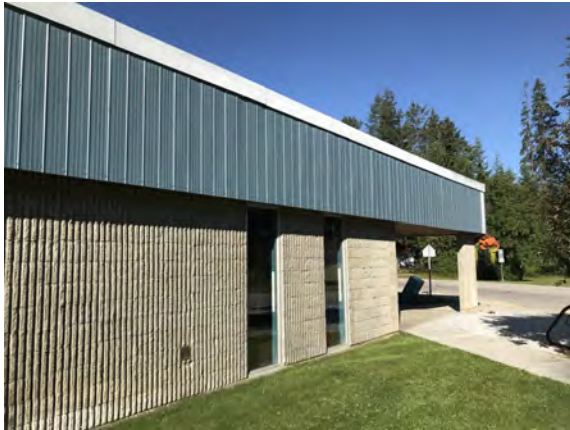
Golden Municipal Swimming Pool - B202001

No major deficiencies were observed or reported during the assessment.

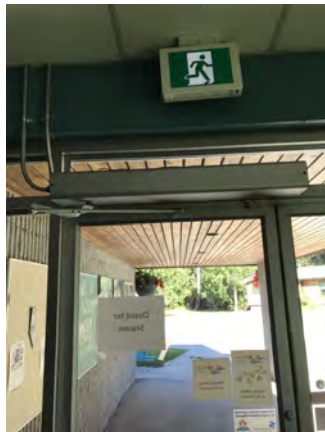
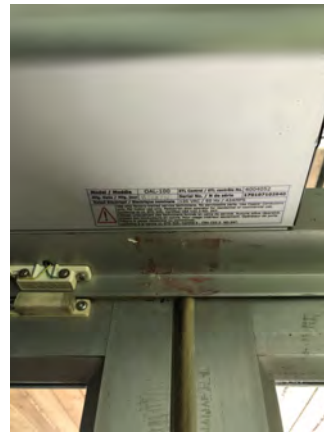
Golden Municipal Swimming Pool - B203008

No major deficiencies were observed or reported during the assessment.

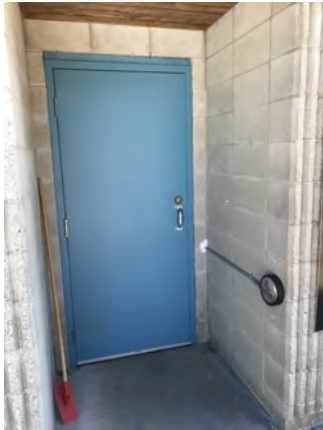
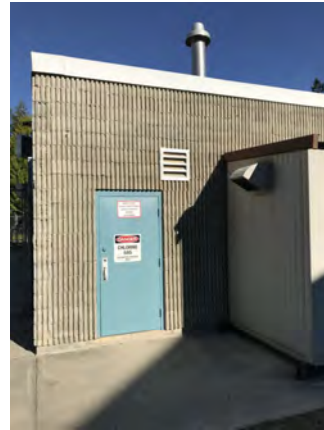
Golden Municipal Swimming Pool - B203023

No major deficiencies were observed or reported during the assessment.

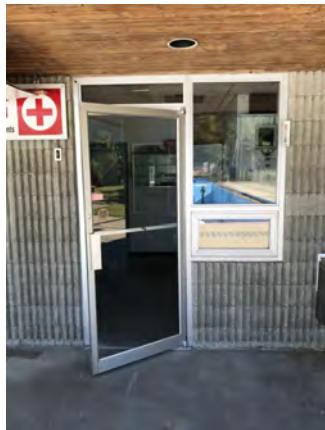
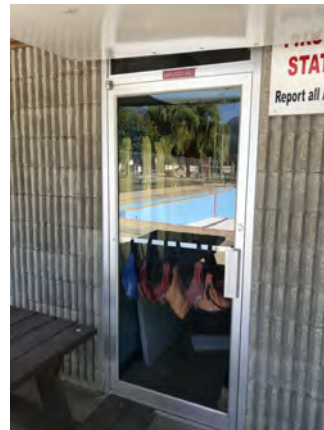
Golden Municipal Swimming Pool - B203025

No major deficiencies were observed or reported during the assessment.

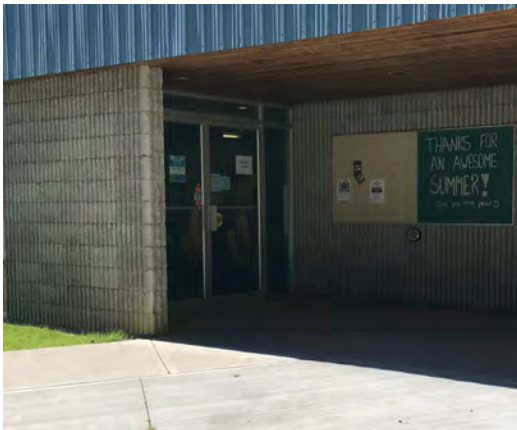
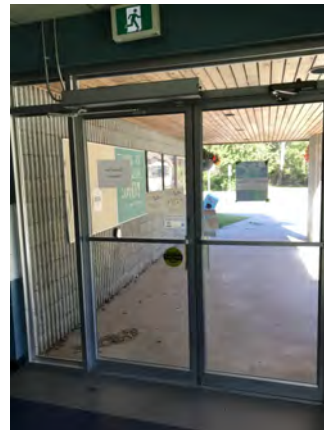
Golden Municipal Swimming Pool - B203028

No major deficiencies were observed or reported during the assessment.

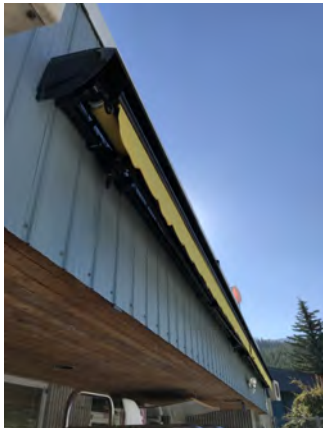
Golden Municipal Swimming Pool - B301099

No major deficiencies were observed or reported during the assessment.

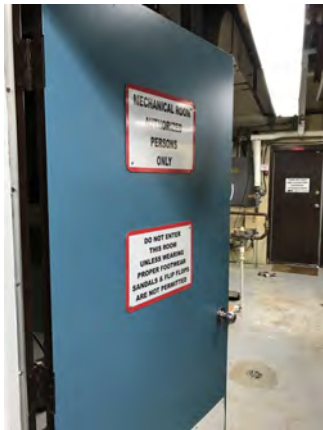
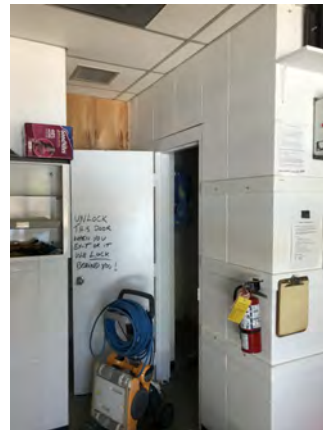
Golden Municipal Swimming Pool - C102021

No major deficiencies were observed or reported during the assessment.

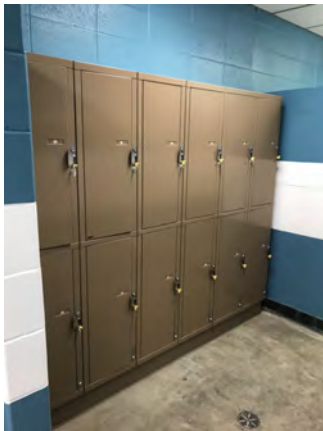
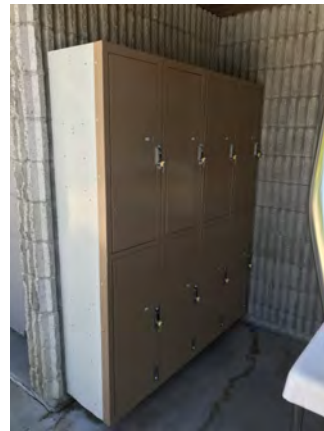
Golden Municipal Swimming Pool - C103006

No major deficiencies were observed or reported during the assessment.

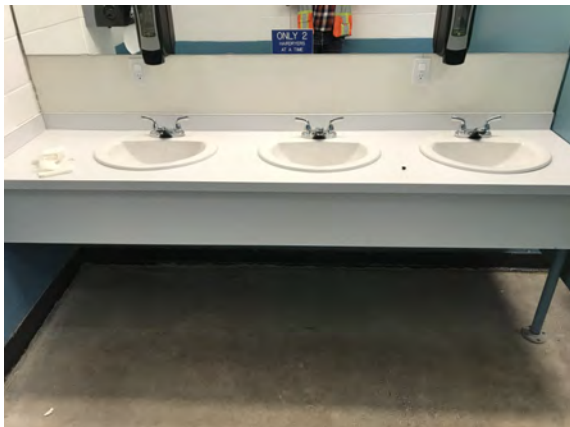
Golden Municipal Swimming Pool - C103010

No major deficiencies were observed or reported during the assessment.

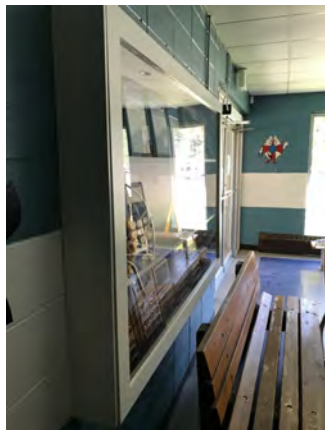
Golden Municipal Swimming Pool - C103008

No major deficiencies were observed or reported during the assessment.

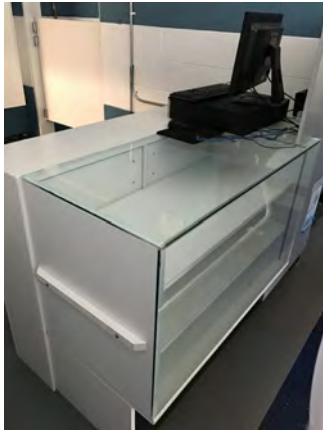
Golden Municipal Swimming Pool - C103008

No major deficiencies were observed or reported during the assessment.

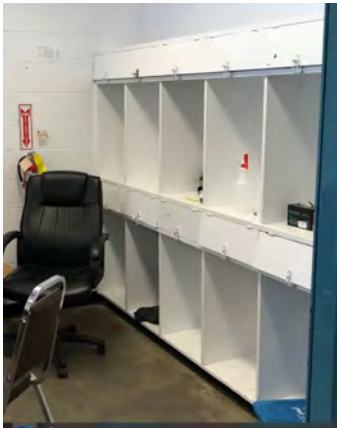
Golden Municipal Swimming Pool - C103008

No major deficiencies were observed or reported during the assessment.

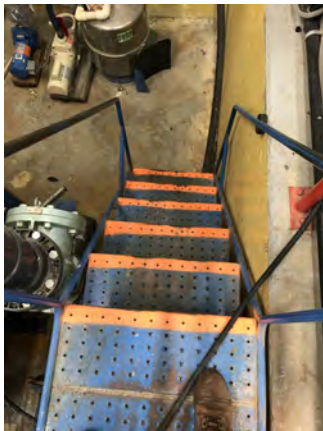
Golden Municipal Swimming Pool - C201001

No major deficiencies were observed or reported during the assessment. The stairs were observed to be very steep. It is recommended to review national building code requirements to ensure this set of stairs complies with regulations.

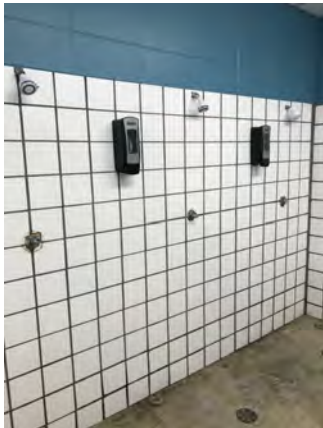
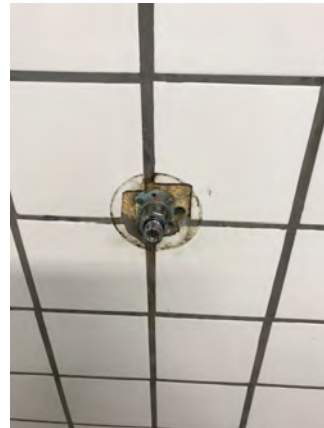
Golden Municipal Swimming Pool - C301023

No major deficiencies were observed or reported during the assessment.

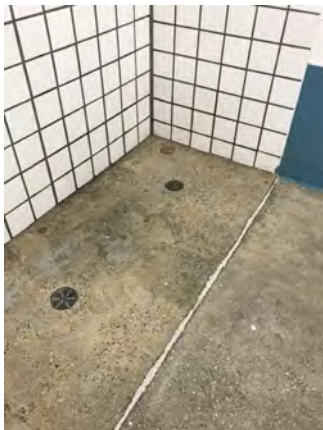
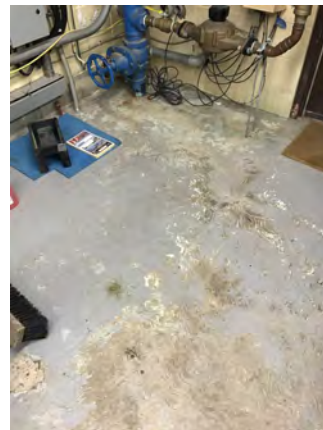
Golden Municipal Swimming Pool - C302007

The floor finish has exceeded its Expected Useful Life (EUL) and is exhibiting heavy wear and tear that is consistent with age. What appeared to be minor surface cracking was present in some areas. The finish overall, is pitted and rough. The floor finish has fully deteriorated in some areas. It is understood that there are frequent complaints from pool users. It is recommended to polish and reseal the concrete floor in common areas where there is bare concrete and to repaint the mechanical room floor. Any repairs such as sealing cracks should be completed at the time of lifecycle replacement.

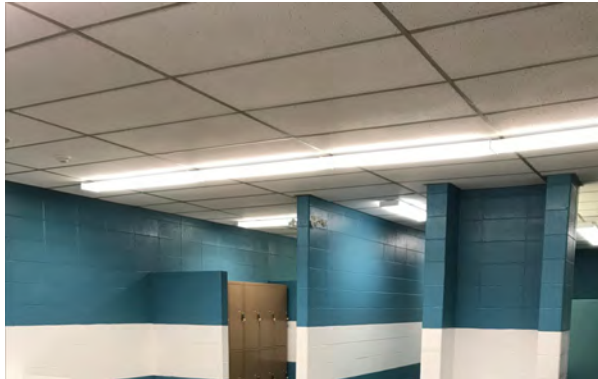
Golden Municipal Swimming Pool - C303004

No major deficiencies were observed or reported during the assessment.

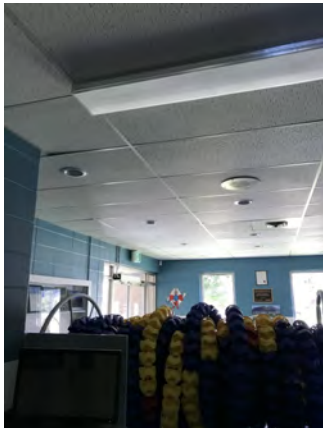
Golden Municipal Swimming Pool - C303004

No major deficiencies were observed or reported during the assessment.

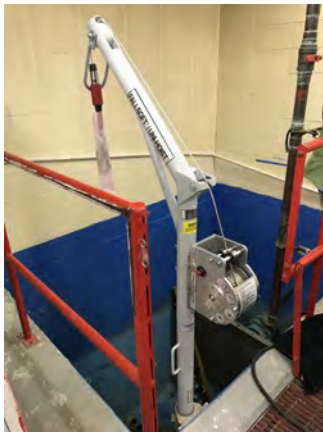
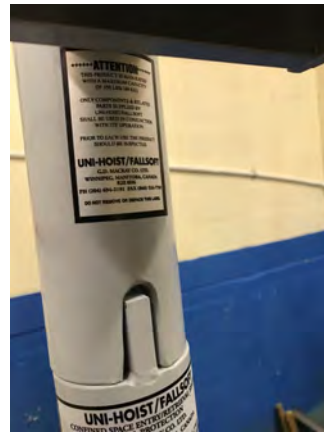
Golden Municipal Swimming Pool - D109009

No major deficiencies were observed or reported during the assessment.

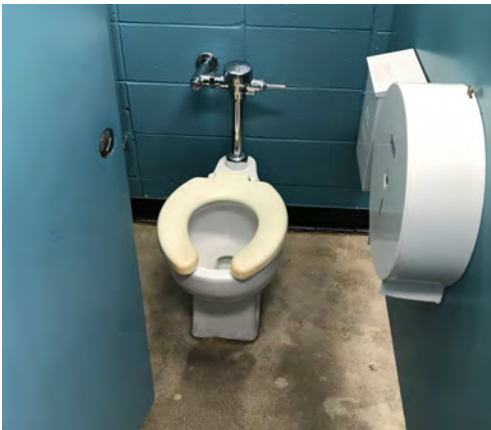
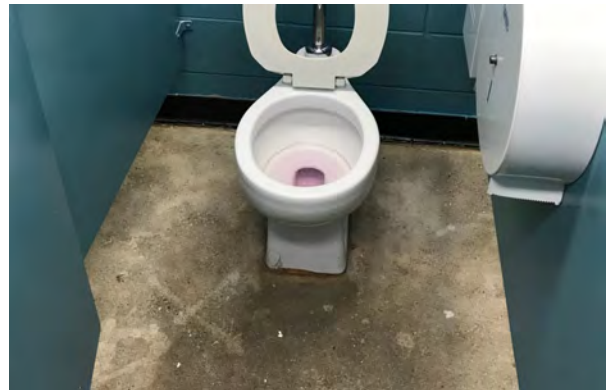
Golden Municipal Swimming Pool - D201001

Water closets have exceeded their Estimated Useful Life (EUL) and are exhibiting wear and tear that is consistent with age. There were instances of chipping at the base of some units. It is recommended to install touchless flush valves at the time of lifecycle replacement. These units should be considered for lifecycle replacement.

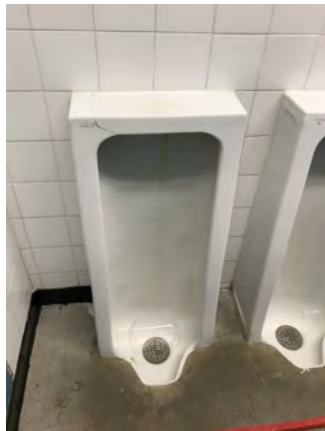
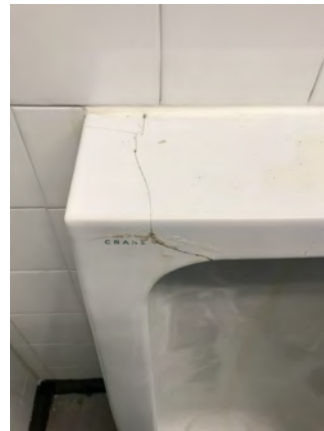
Golden Municipal Swimming Pool - D201002

Water closets have exceeded their Estimated Useful Life (EUL) and are exhibiting wear and tear that is consistent with age. One unit is cracked and broken. It is recommended to consider replacing these components with urinal assemblies that include dedicated, touchless flush valves to use less water and run less frequently. The urinals should be considered for lifecycle replacement.

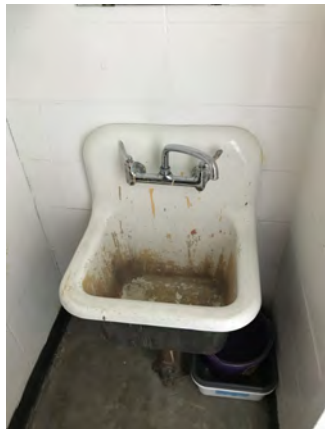
Golden Municipal Swimming Pool - D201016

The sink has exceeded its Expected Useful Life (EUL) and is exhibiting wear and tear that is consistent with age. There is excessive staining in the basin. It is recommended to consider this component for lifecycle replacement within the next five years. It was noted that there was no sink installed in the mechanical room. Due to the nature of the chemicals used for the swimming and wading pool it is recommended to install a hand washing station in the mechanical room. A repair item has been created to install a sink in the mechanical room.

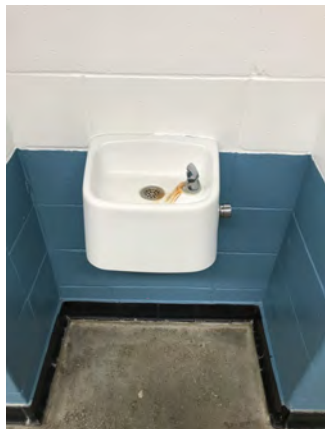
Golden Municipal Swimming Pool - D201006

The water fountains have exceeded their Expected Useful Life (EUL) and are exhibiting wear and tear that is consistent with age. There is staining on the finishes and corrosion/pitting on the fittings and water-spouts. This component should be considered for lifecycle replacement within the next two years.

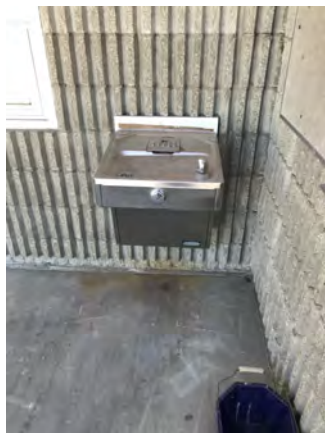
Golden Municipal Swimming Pool - D201006

No major deficiencies were observed or reported during the assessment.

Replace Drinking Water Fountains - Non-refrigerated

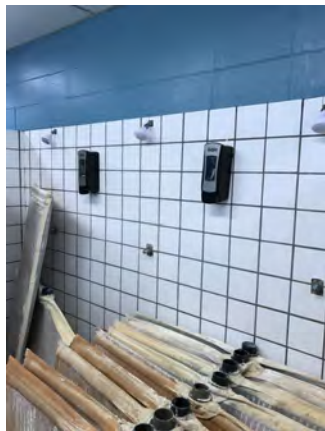
Golden Municipal Swimming Pool - D201011

There are gang showers installed in the male and female change rooms, each with three (3) through-wall valve sets and showerheads. There is one (1) through-wall valve-set installed in the staff shower. Showerheads have been replaced through regular maintenance, however the piping and valves appear to be original.

No major deficiencies were observed or reported during the assessment.

Replace Showers (Valve Set)

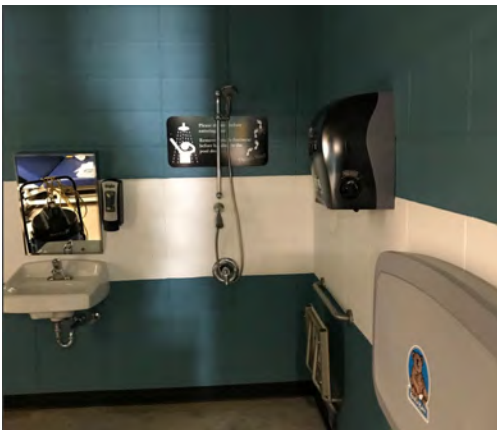
Golden Municipal Swimming Pool - D201011

No major deficiencies were observed or reported during the assessment.

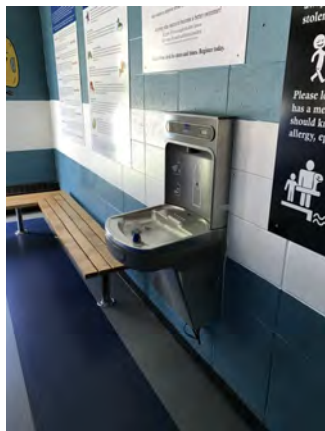
Golden Municipal Swimming Pool - D201015

No major deficiencies were observed or reported during the assessment.

Replace Drinking Water Fountains - Refrigerated

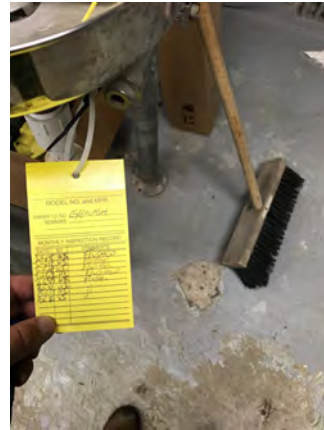
Golden Municipal Swimming Pool - D201031

No major deficiencies were observed or reported during the assessment.

Replace Eyewash Stations

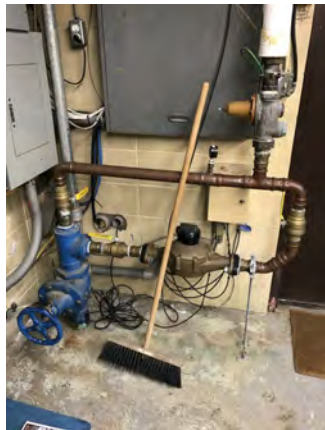
Golden Municipal Swimming Pool - D202001

No major deficiencies were observed or reported during the assessment. Given the nature of the component, full-scale replacement is not expected to be required. However, a cost allowance for partial replacement has been carried forward in this report as a precautionary measure.

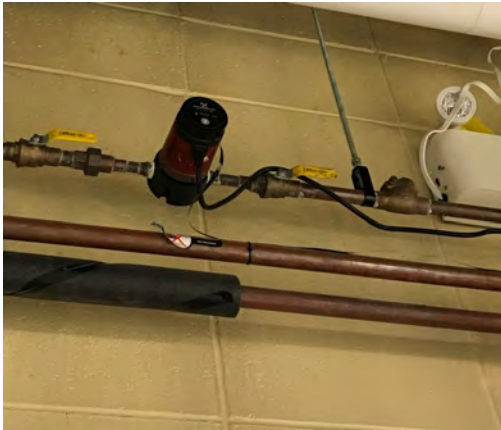
Golden Municipal Swimming Pool - D202007

No major deficiencies were observed or reported during the assessment.

Replace Domestic Water Circulating Pumps

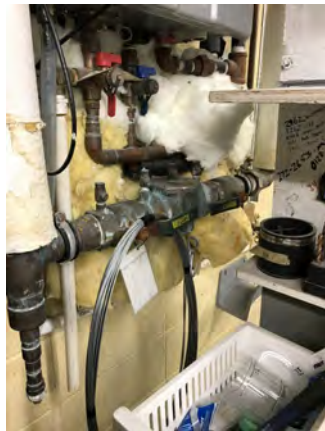
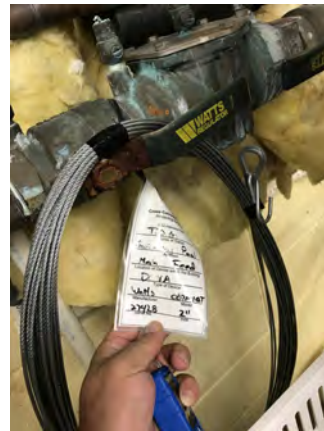
Golden Municipal Swimming Pool - D202009

The backflow prevention devices are nearing their Expected Useful Life (EUL) and are exhibiting signs of wear and tear that is consistent with age. There was some minor rust and pitting observed. It is recommended to consider these units for replacement within the next five years.

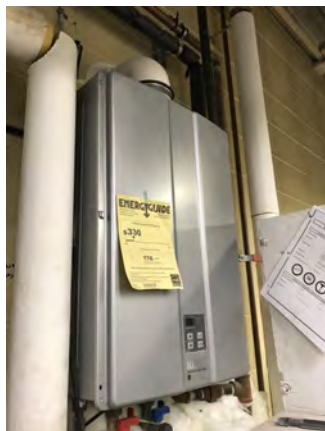
Golden Municipal Swimming Pool - D202037

No major deficiencies were observed or reported during the assessment.

Replace Domestic Water Heater (Instanteous)

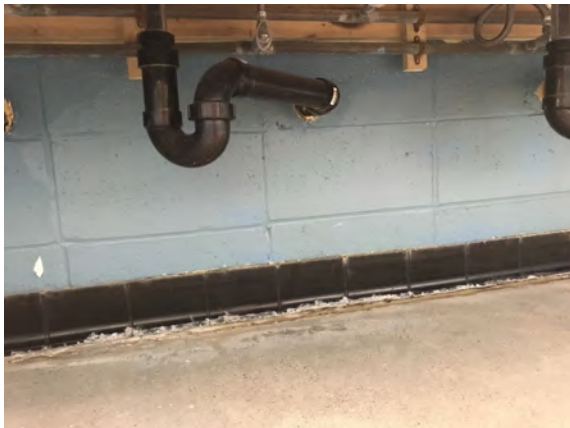
Golden Municipal Swimming Pool - D203001

No major deficiencies were observed or reported during the assessment. Given the nature of the component, full-scale replacement is not expected to be required. However, a cost allowance for partial replacement has been carried forward in this report as a precautionary measure.

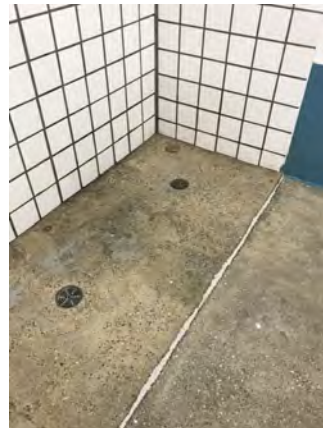
Golden Municipal Swimming Pool - D203001

Sanitary lines are a mix of ABS and assumed cast iron piping and connect fixture and floor drains to common lines to a common exit to site sanitary lines. Sanitary waste and vent piping is primarily concealed within wall, floor, or ceiling finishes. The a 150 mm main sanitary line exits the building west side. It is understood that portions of the sanitary piping were replaced or upgraded during the 2016 building renovation to provide an accessibility washroom.

Replace Sanitary Waste and Vent Piping

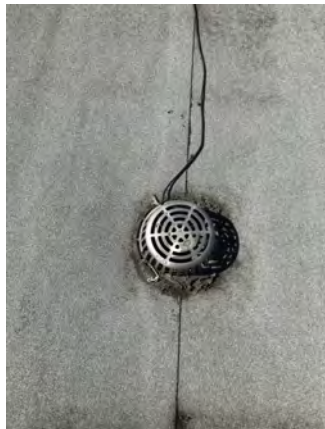
Golden Municipal Swimming Pool - D204001

Roof drains connect to assumed cast iron internal rainwater leaders. According to the drawings provided for this facility, the rainwater piping connects to a common rainwater leader to direct rainwater to a concrete splash pad installed on the north elevation; however there was no splash pad observed onsite. It is suspected that rainwater piping may connect to the outgoing sanitary drain line.

No major deficiencies were observed or reported during the assessment. Given the nature of the component, full-scale replacement is not expected to be required. However, a cost allowance for partial replacement has been carried forward in this report as a precautionary measure.

Replace Rain Water Drainage Piping and Fittings

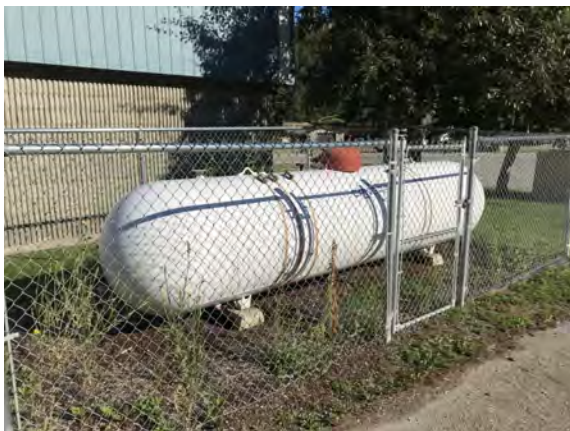
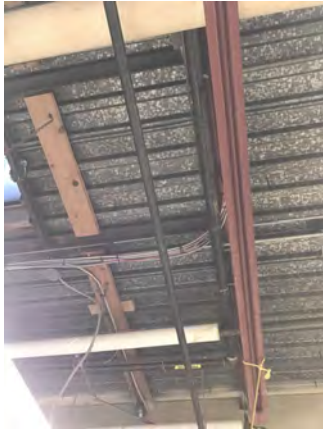
Golden Municipal Swimming Pool - D301002

No major deficiencies were observed or reported during the assessment. Paint on the steel lines should be touched up as needed as a maintenance activity. Given the nature of the component, full-scale replacement is not expected to be required. However, a cost allowance for partial replacement has been carried forward in this report as a precautionary measure.

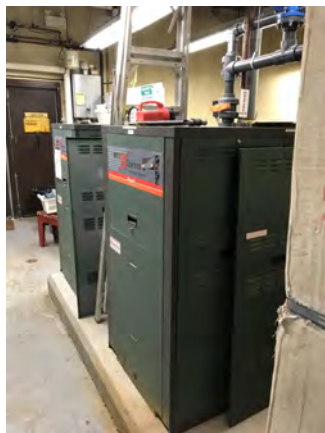
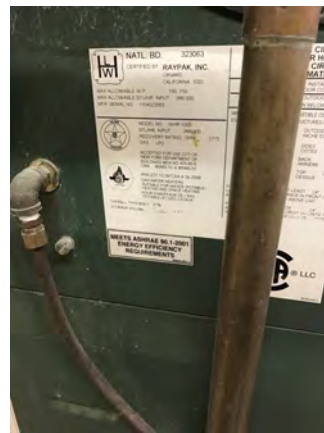
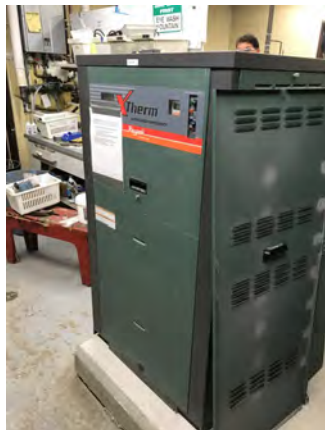
Golden Municipal Swimming Pool - D302002

No major deficiencies were observed or reported during the assessment.

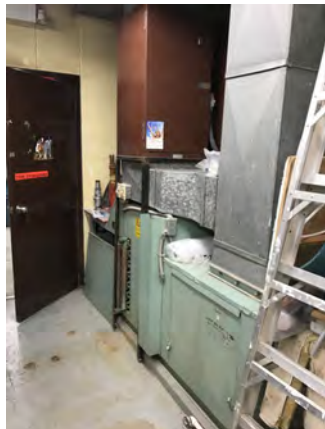
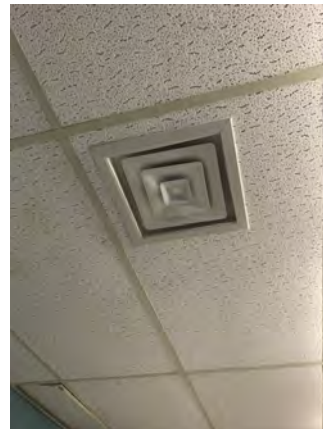
Golden Municipal Swimming Pool - D304001

No major deficiencies were observed or reported during the assessment. Given the nature of the component, full-scale replacement is not expected to be required. However, a cost allowance for partial replacement has been carried forward in this report as a precautionary measure.

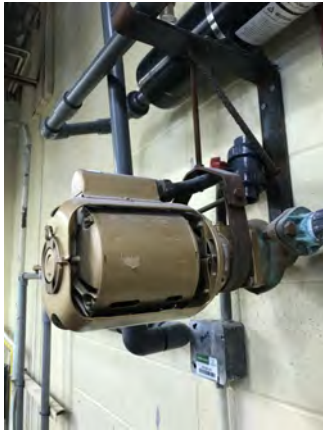
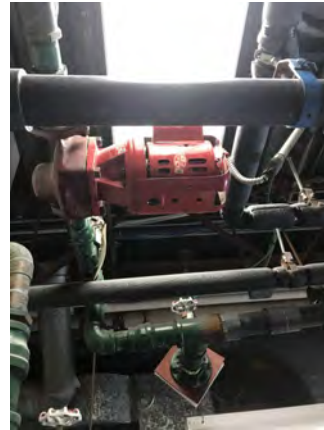
Golden Municipal Swimming Pool - D304021

No major deficiencies were observed or reported during the assessment.

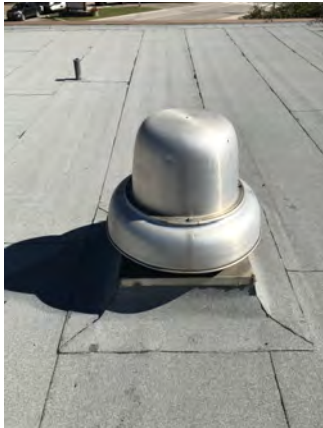
Golden Municipal Swimming Pool - D304031

The exhaust fans have exceeded their Expected Useful Life (EUL) and are exhibiting wear and tear that is consistent with age. These components should be considered for lifecycle replacement. It was noted that there was a general lack of exhaust within the mechanical room. This space contains chemical components associated with the swimming pool systems such as diatomaceous earth (DE). It is recommended that adequate exhaust requirements be reviewed by a licensed HVAC technician or engineer. A repair cost to install a dedicated exhaust fan and associated ventilation ductwork for the mechanical room has been provided.

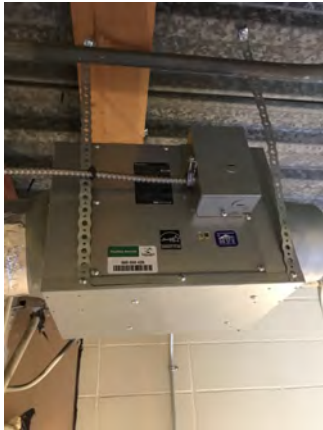
Golden Municipal Swimming Pool - D304032

No major deficiencies were observed or reported during the assessment.

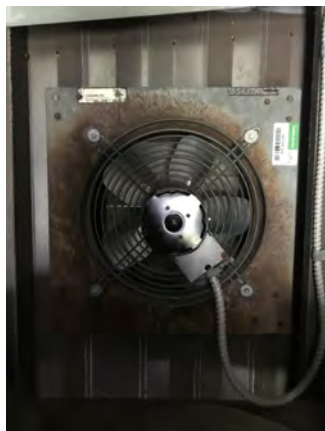
Golden Municipal Swimming Pool - D304032

The fan is nearing its Expected Useful Life (EUL) and is exhibiting wear and tear that is consistent with age. It is expected to require lifecycle replacement within the next five years.

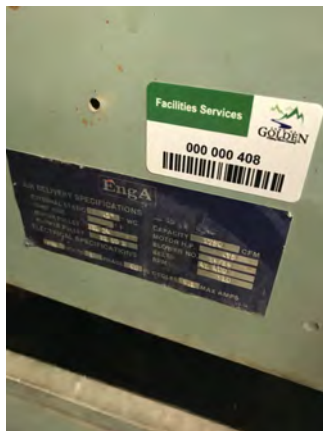
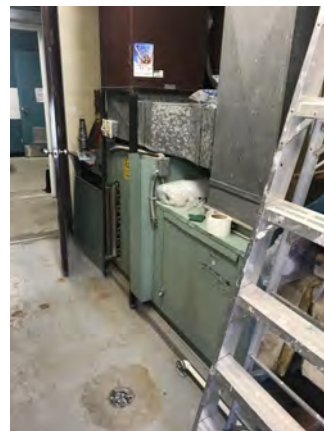
Golden Municipal Swimming Pool - D304043

This component was decommissioned at the time of assessment and water to heating coils was disconnected. It is understood that the system is no longer in use, but it is unknown if it was a result of equipment failure or changes to the HVAC layout. The need for this unit should be reviewed. If it is not required it should be removed. This unit is currently not operable. A lifecycle cost to replace this unit has been provided.

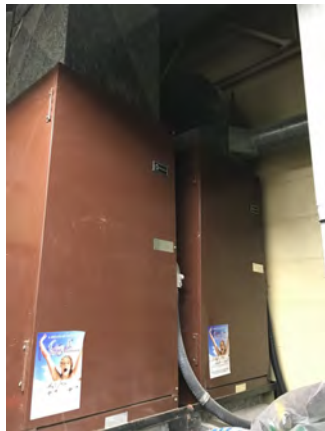
Golden Municipal Swimming Pool - D305011

The furnaces have exceeded their Expected Useful Life (EUL) and are exhibiting wear and tear that is consistent with the age of the components. Repair and replacement parts may be difficult to obtain due to obsolescence. It is recommended to consider the furnaces for lifecycle replacement within the next three years.

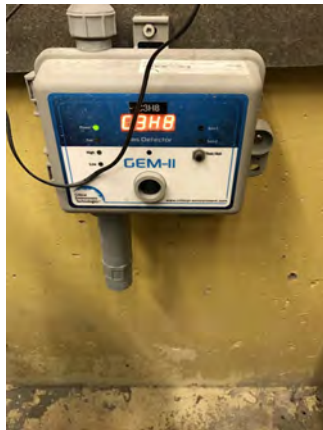
Golden Municipal Swimming Pool - D306011

No major deficiencies were observed or reported during the assessment.

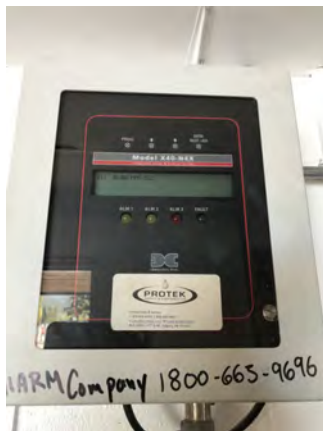
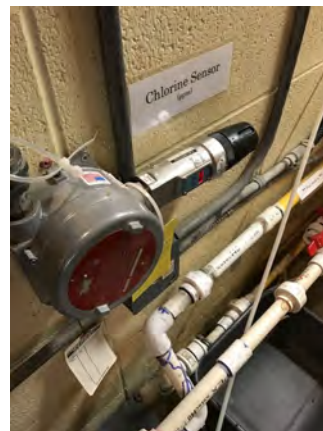
Golden Municipal Swimming Pool - D306011

No major deficiencies were observed or reported during the assessment.

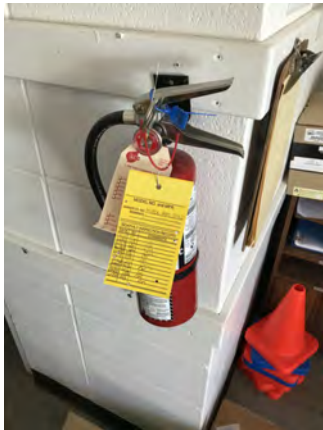
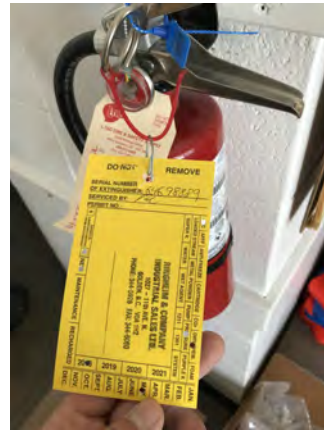
Golden Municipal Swimming Pool - D403002

No major deficiencies were observed or reported during the assessment.

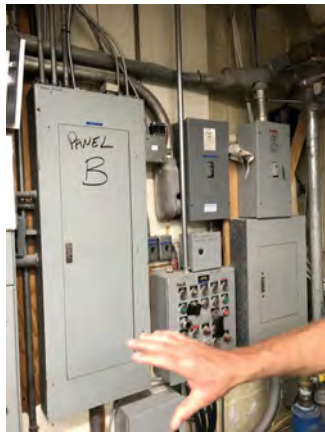
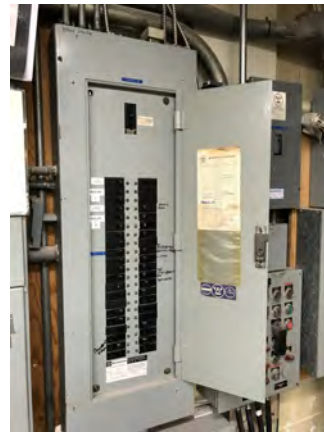
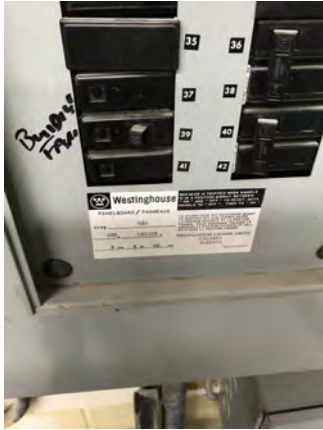
Golden Municipal Swimming Pool - D501005

No major deficiencies were observed or reported during the assessment.

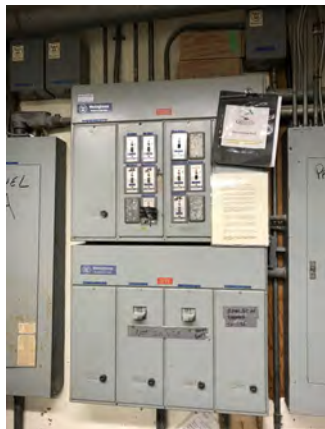
Golden Municipal Swimming Pool - D501007

The motor control centre has exceeded its Expected Useful Life (EUL) and is exhibiting wear and tear that is consistent with age. It is recommended to consider this equipment for lifecycle replacement within the next five years.

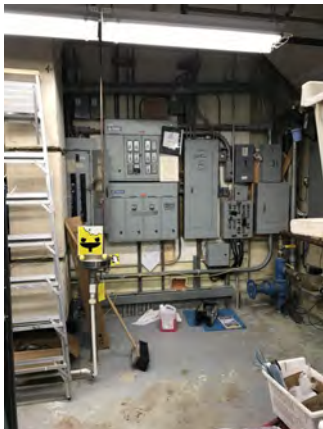
Golden Municipal Swimming Pool - D502001

No major deficiencies were observed or reported during the assessment. Given the nature of the component, full-scale replacement is not expected to be required. However, a cost allowance for partial replacement has been carried forward in this report as a precautionary measure.

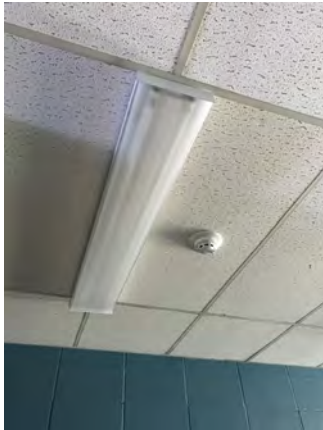
Golden Municipal Swimming Pool - D502002

No major deficiencies were observed or reported during the assessment.

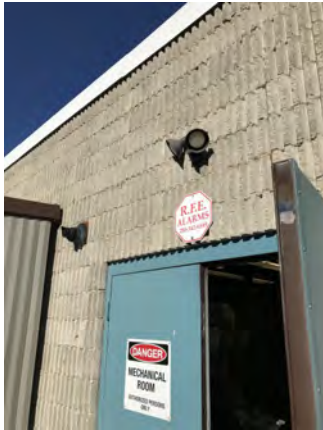
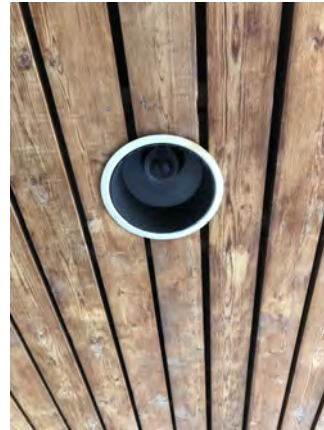
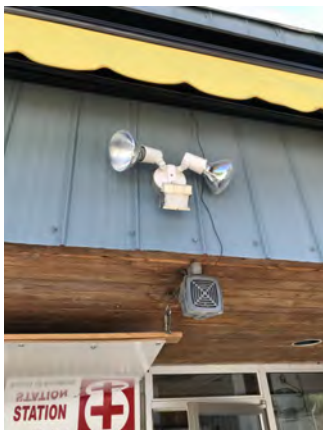
Golden Municipal Swimming Pool - D502041

No major deficiencies were observed or reported during the assessment.

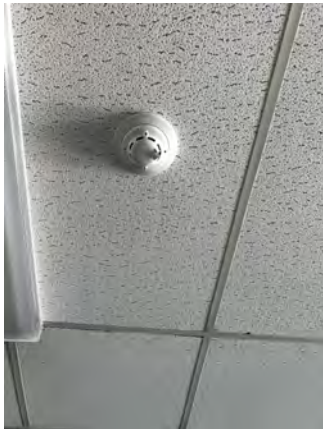
Golden Municipal Swimming Pool - D503001

No major deficiencies were observed or reported during the assessment; however some units were observed to be older. It is recommended to test the smoke alarms regularly and replace as required as a preventative maintenance activity.

Recommendations #1 - Fire Alarm Systems	
Type	Life Cycle Replacement
Year	2026
Cost	\$9,296.88

Replace Fire Alarm Systems

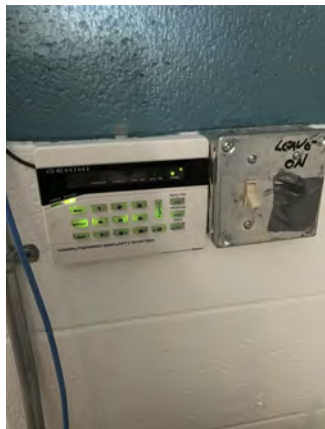
Golden Municipal Swimming Pool - D503008

No major deficiencies were observed or reported during the assessment.

Recommendations #1 - Security Systems - Intrusion Alarm Systems	
Type	Life Cycle Replacement
Year	2030
Cost	\$5,312.50

Replace Security Systems - Intrusion Alarm Systems

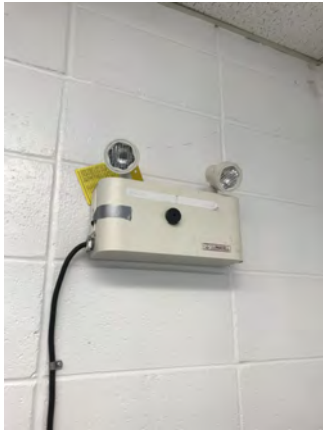
Golden Municipal Swimming Pool - D509003

No major deficiencies were observed or reported during the assessment.

Recommendations #1 - Emergency Lighting Systems	
Type	Life Cycle Replacement
Year	2030
Cost	\$2,656.25

Replace Emergency Lighting Systems

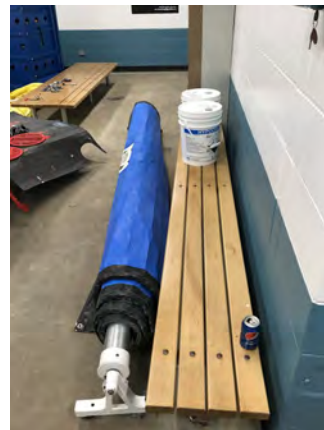
Golden Municipal Swimming Pool - E201005

No major deficiencies were observed or reported during the assessment.

Recommendations #1 - Benches	
Type	Life Cycle Replacement
Year	2025
Cost	\$9,750.00

Replace Benches

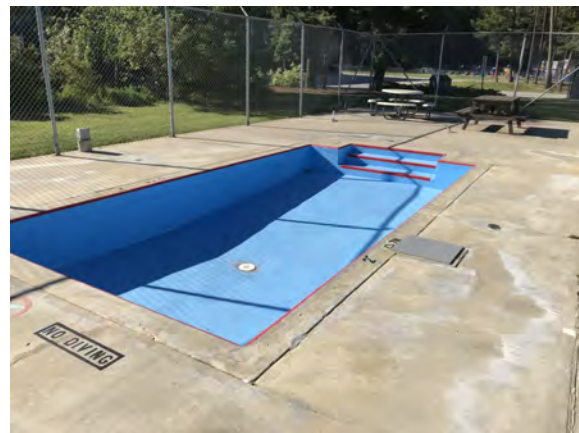
Golden Municipal Swimming Pool - F104001

The wading pool basin is exhibiting wear and tear that is consistent with the age of the material. While there appears to be no through-wall cracking or leaks, there are some minor cracks. There is extensive pocking of concrete in the basin. There is general delamination in concrete edges around the drain. It is recommended to replace the wading pool basin at the time of pool deck replacement to minimize mobilization costs. This basin is included in the recommended engineering study to determine the full scope of work for lifecycle replacements of pool systems.

Recommendations #1 - Pool Structure	
Type	Life Cycle Replacement
Year	2025
Cost	\$25,200.00

Replace Pool Structure

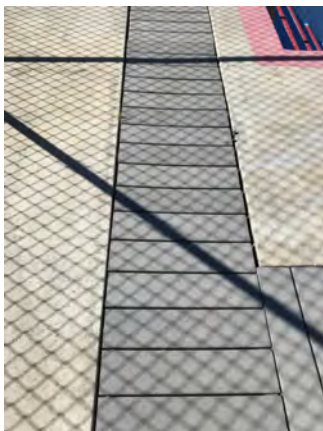
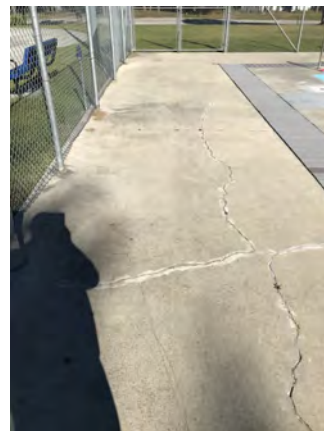
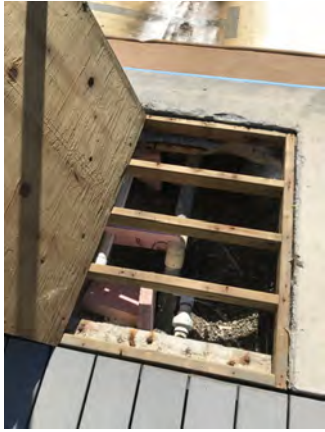
Golden Municipal Swimming Pool - F104001

The pool decking is exhibiting wear and tear that is consistent with the age of the material. There were several cracks and instances of concrete delamination observed around concrete edges, drains, and expansion/control joints. There is reportedly cracking present in the pipe trench. Composite slats covering the pipe trench were observed to be expanding and deteriorating, making removal and replacement difficult. It is recommended to consider the pool decking/trenching for lifecycle replacement in the near future. At the time of lifecycle replacement of the pool decking it is recommended to replace both pool basins to minimize project mobilization costs.

Recommendations #1 - Pool Structure	
Type	Life Cycle Replacement
Year	2022
Cost	\$226,800.00

Replace Pool Structure

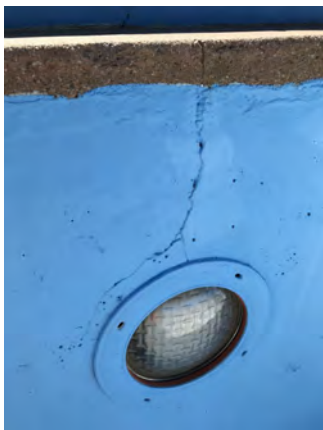
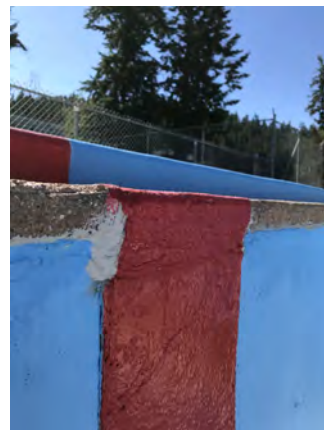
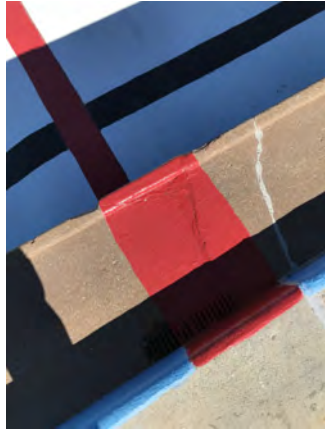
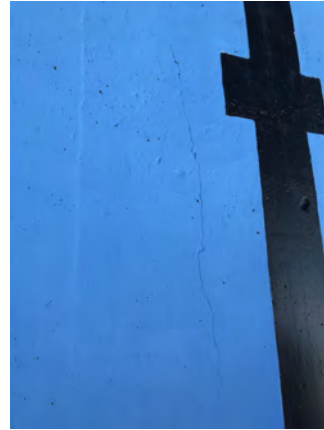
Golden Municipal Swimming Pool - F104001

The swimming pool basin is exhibiting wear and tear that is consistent with the age of the material. While there appears to be no through-wall cracking or leaks, there are some cracks and suspected delamination of concrete. Concrete around some skimmers was observed to be cracked and delaminated. There were some cracks observed that had been filled with sealant. There is extensive pocking of concrete in the pool below the water fill line. Coping along the pool edge exhibited cracks and delamination. There is general delamination in concrete edges around drains, coping, skimmers, and expansion joints. It is recommended to replace the swimming pool basin at the time of pool deck replacement to minimize mobilization costs. In the meantime, it is recommended to allocate funds for ongoing repairs. A repair requirement has been created for 2021. Due to the age of the pool systems and infrastructure it is recommended to undertake an engineering study. A study has been created to review existing pool systems and provide a full scope of work for recommendations, replacements, repairs, and upgrades to the existing swimming pool systems and infrastructure. The study should account for possible energy savings and savings in operating costs.

Recommendations #1 - Repair Pool Basin

Type	Repair
Year	2021
Cost	\$7,000.00

Complete as needed repairs to the pool basin, including but not limited to; sealing cracks, repairing delaminated concrete, repainting.

Recommendations #2 - Pool Structure Review

Using a qualified engineer, complete a review of pool infrastructure and mechanical components and draft a scope of work for repairs, upgrades, and replacements. The scope of the work should take energy savings and operational costs into account. The study should include the all pool mechanical systems, infrastructure, controls, water treatment, and piping.

Recommendations #3 - Pool Structure

Type	Life Cycle Replacement
Year	2022
Cost	\$168,000.00

Replace Pool Structure

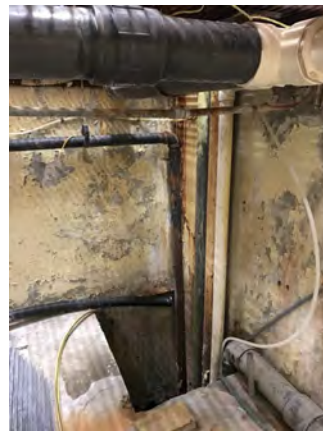
Golden Municipal Swimming Pool - F104002

The pool piping has exceeded its Expected Useful Life (EUL) and is exhibiting wear and tear that is consistent with the age of the material. Portions of visible piping were observed to be rusted and corroded. The piping to the filter pit is reportedly leaking. It is recommended to replace any remaining original pool piping at the time of pool deck replacement.

Recommendations #1 - Pool Water Circulation Piping	
Type	Life Cycle Replacement
Year	2022
Cost	\$45,000.00

Replace Pool Water Circulation Piping

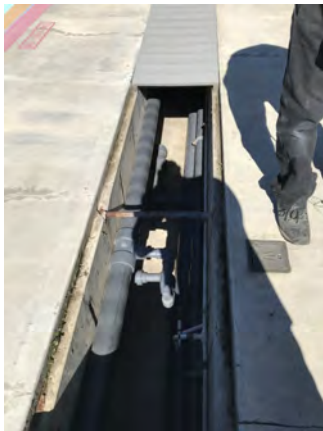
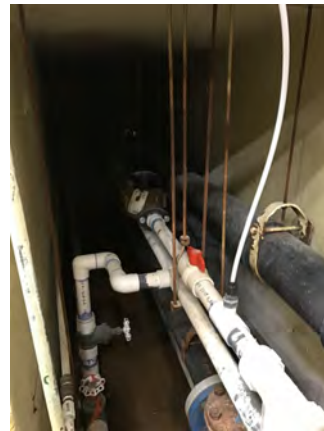
Golden Municipal Swimming Pool - F104002

Raceway piping is PVC and primarily contained within the raceway, below grade, and in the mechanical room. Portions of the wading pool piping in the mechanical room have been replaced, including the main fill line.

No major deficiencies were observed or reported during the assessment.

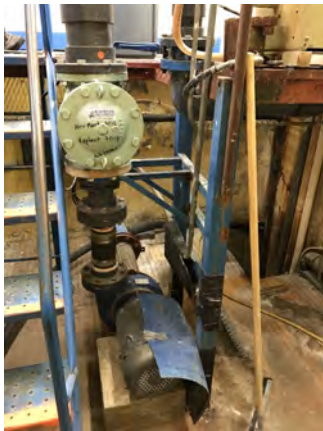
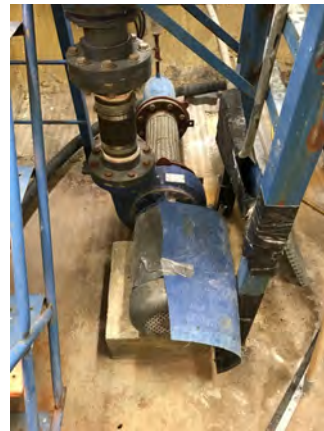
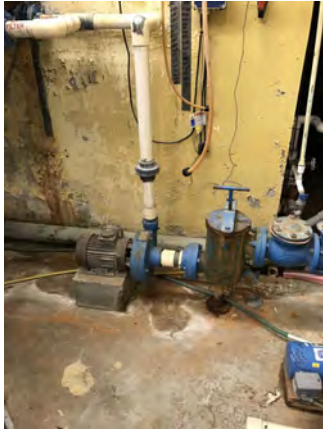
Golden Municipal Swimming Pool - F104003

This pump is believed to be nearing its Expected Useful Life (EUL) and is exhibiting wear and tear that is consistent with age. It is likely that this component will require lifecycle replacement. The decommissioned pump should be removed to prevent confusion, and pipe ends capped. No cost allowance has been included for this action.

Recommendations #1 - Pool Water Circulation Pumps	
Type	Life Cycle Replacement
Year	2025
Cost	\$4,687.50

Replace Pool Water Circulation Pumps

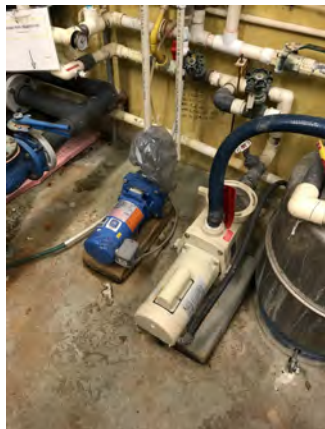
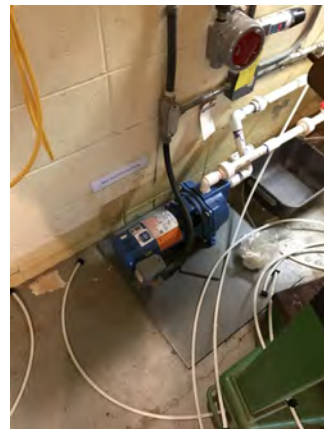
Golden Municipal Swimming Pool - F104003

No major deficiencies were observed or reported during the assessment.

Recommendations #1 - Pool Water Circulation Pumps	
Type	Life Cycle Replacement
Year	2039
Cost	\$15,000.00

Replace Pool Water Circulation Pumps

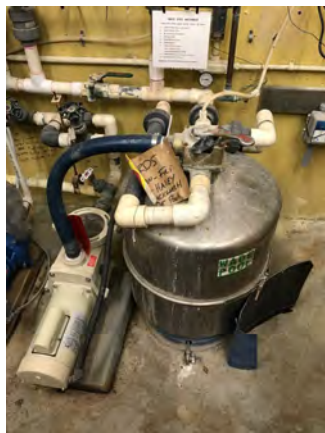
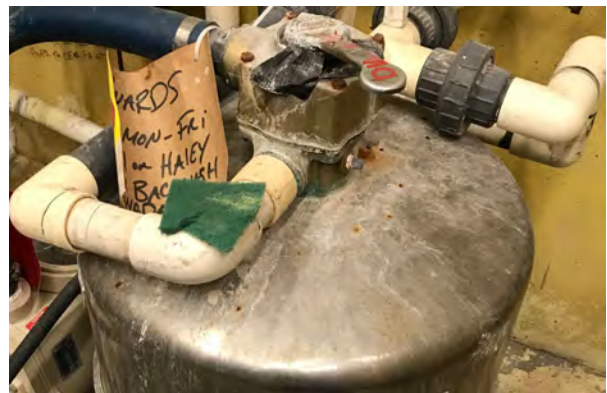
Golden Municipal Swimming Pool - F104006

The sand filter is believed to have exceeded its Expected Useful Life (EUL) and is exhibiting wear and tear that is consistent with age. There was some rust observed on the outer shell of the sand filter. Replacement is recommended.

Replace Pool Sand Filters

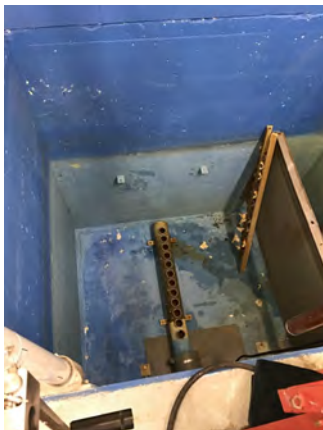
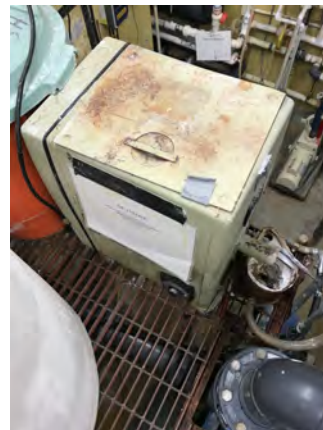
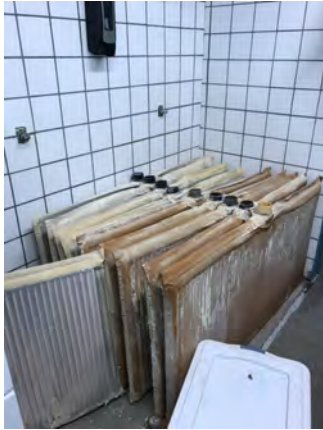
Golden Municipal Swimming Pool - F104006

The DE filtration system has exceeded its Expected Useful Life and is exhibiting wear and tear that is consistent with the age of the material. It is recommended to consider this system for lifecycle replacement within the near future. It is recommended to replace this system with a conventional sand filter system, which is typically easier to maintain and flush, while not exposing workers to DE powder. The cost adjustment factor has been increased by a large amount to account for a full retrofit to a sand filter system.

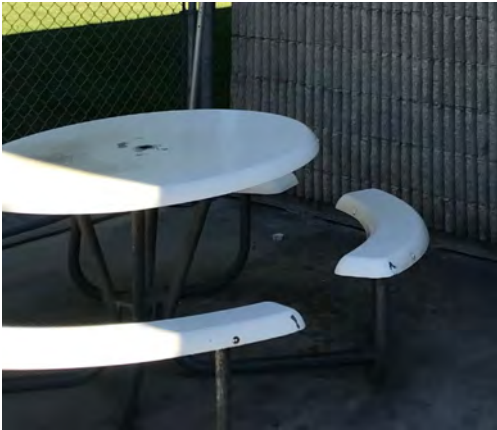
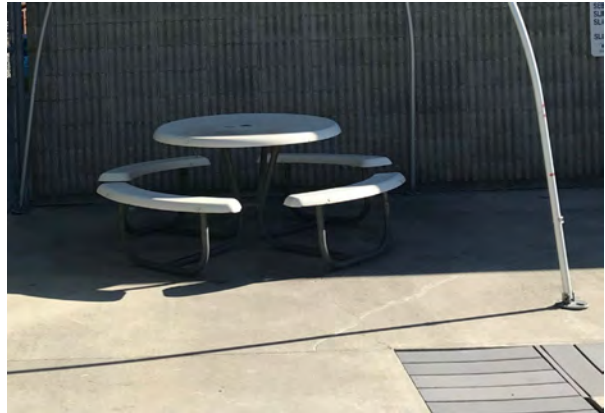
Golden Municipal Swimming Pool - G204074

The picnic table has exceeded its Expected Useful Life (EUL) and is exhibiting wear and tear that is consistent with age. Replacement is recommended.

Recommendations #1 - Picnic Tables - Metal	
Type	Life Cycle Replacement
Year	2024
Cost	\$3,750.00

Replace Picnic Tables - Metal

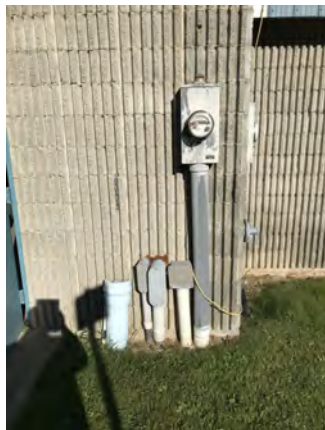
Golden Municipal Swimming Pool - G401011

Element Description	
Name	G401011 - Electrical Service
Installation Year	1978
Condition	2 - Good
Expected Useful Life	50 Years
Remaining Useful Life	8 Years
Renewal Year	2028
Quantity / Unit of Measure	20 / LM
Unit Cost	\$655.00
Difficulty / Regional / Soft Cost Factors	1.00 / 1.25000 / 1.00000
Replacement Cost	\$16,375.00

No major deficiencies were observed or reported during the assessment.

Recommendations #1 - Electrical Service	
Type	Life Cycle Replacement
Year	2028
Cost	\$16,375.00

Replace Electrical Service
