Town of Golden

**Facility Condition Assessment Report
Golden Municipal Swimming Pool**

October 27, 2020

Prepared by:
FCAPX a Division of Roth IAMS Ltd.
Project No. 20079
www.fcapx.com

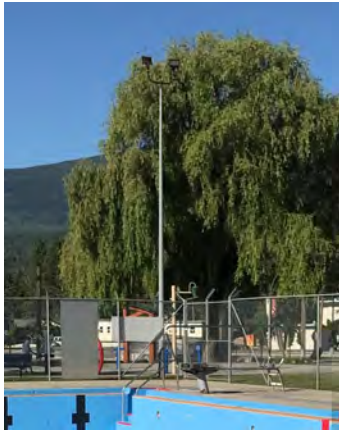
Golden Municipal Swimming Pool - G402011

Element Description	
Name	G402014 - Light Poles - 40' high
Installation Year	1978
Condition	2 - Good
Expected Useful Life	30 Years
Remaining Useful Life	6 Years
Renewal Year	2026
Quantity / Unit of Measure	2 / Each
Unit Cost	\$3,000.00
Difficulty / Regional / Soft Cost Factors	1.50 / 1.25000 / 1.00000
Replacement Cost	\$11,250.00

No major deficiencies were observed or reported during the assessment.

Recommendations #1 - Light Poles - 40' high	
Type	Life Cycle Replacement
Year	2026
Cost	\$11,250.00

Replace Light Poles - 40' high
